# Common FAQs of Infrared thermography on building envelop inspections: 紅外線外牆檢測的常見問題

Ir Dr Wallace LAI, Associate Head and Associate Professor

Department of Land Surveying and Geo-informatics

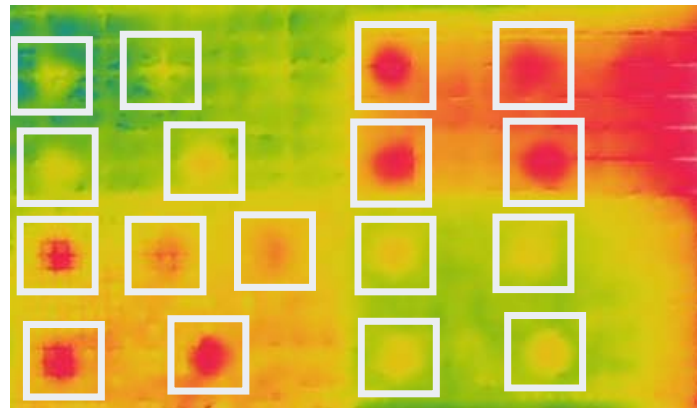
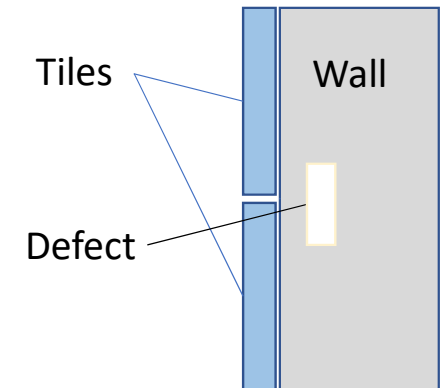
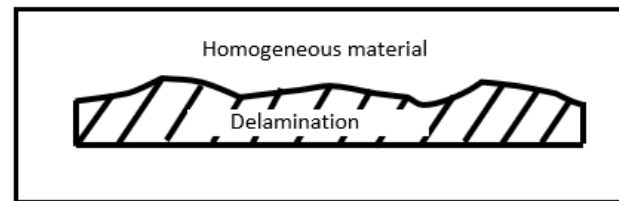
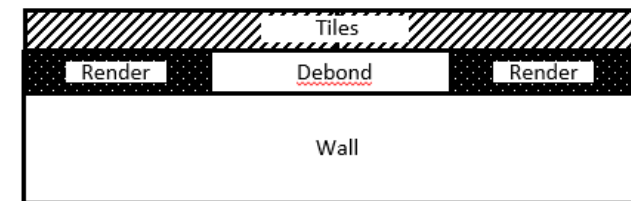
- Looks for defects
  - Delamination
  - Debond
- Defects appear in region of hot temperature

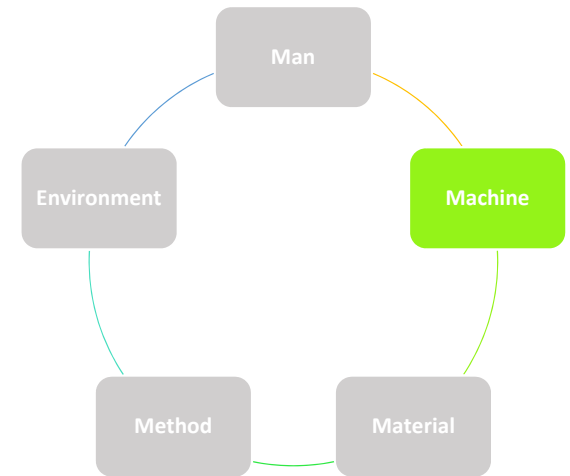
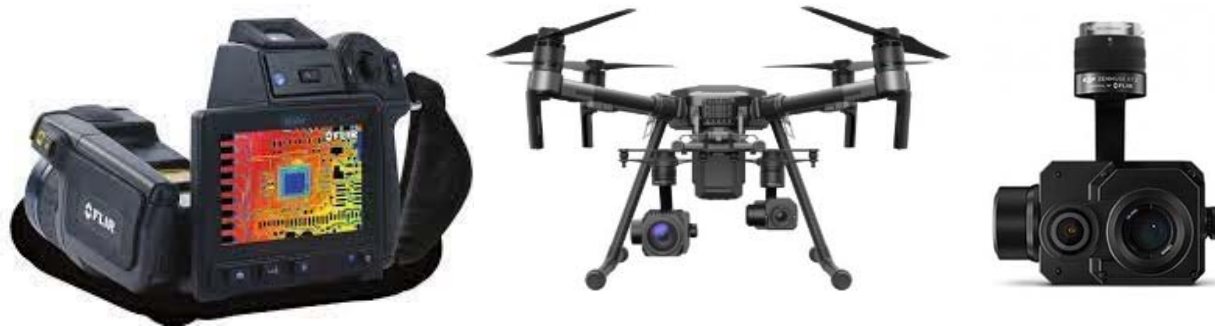
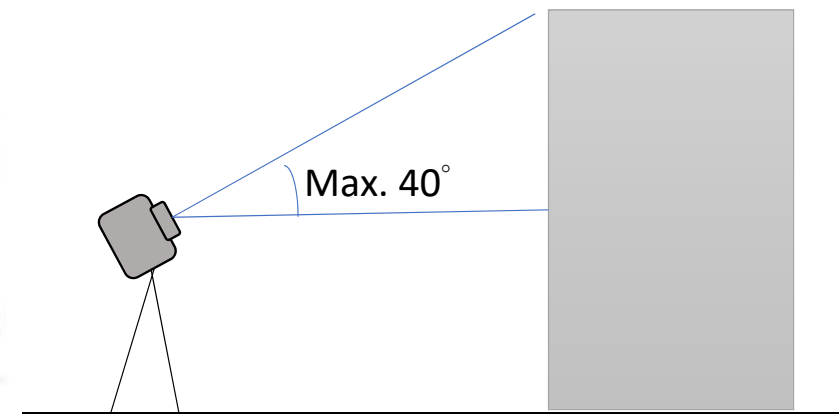
Angle of incidence should be  $< 40^\circ$

- For high-rise buildings, robotic device (e.g. UAV) equipped with radiometric IR camera could be used

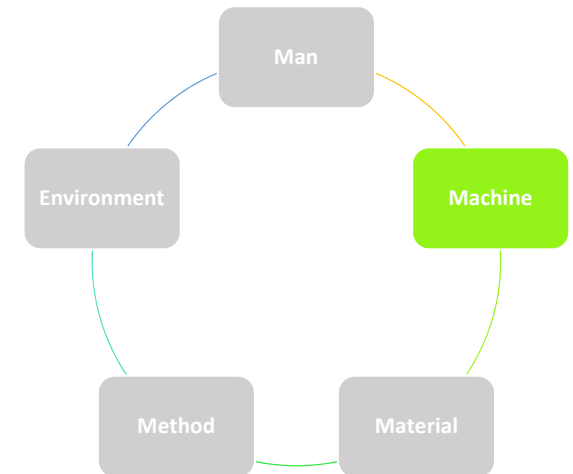
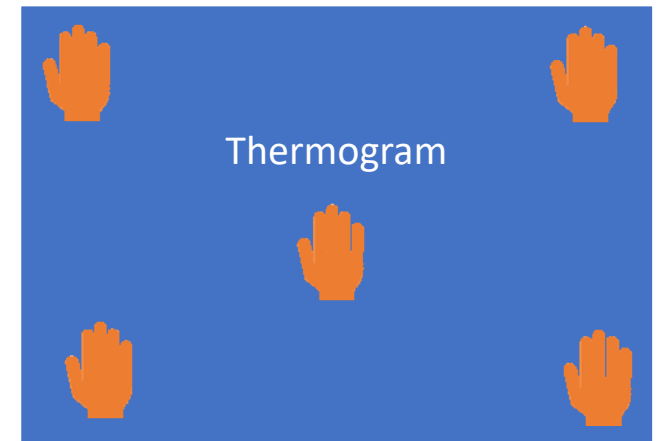
On-site functionality test

*Original:* 3-point test comparing IR-measured temperature and thermocouple-measured temperature. If difference < 2 degC, okay.

*Reviewed:* recognizing a distinct object (e.g. fingers) clearly at five locations

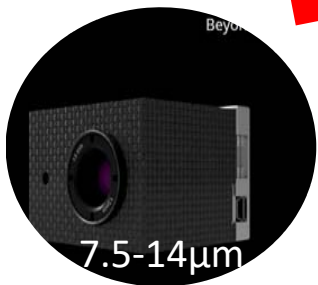
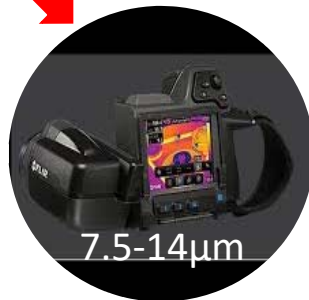
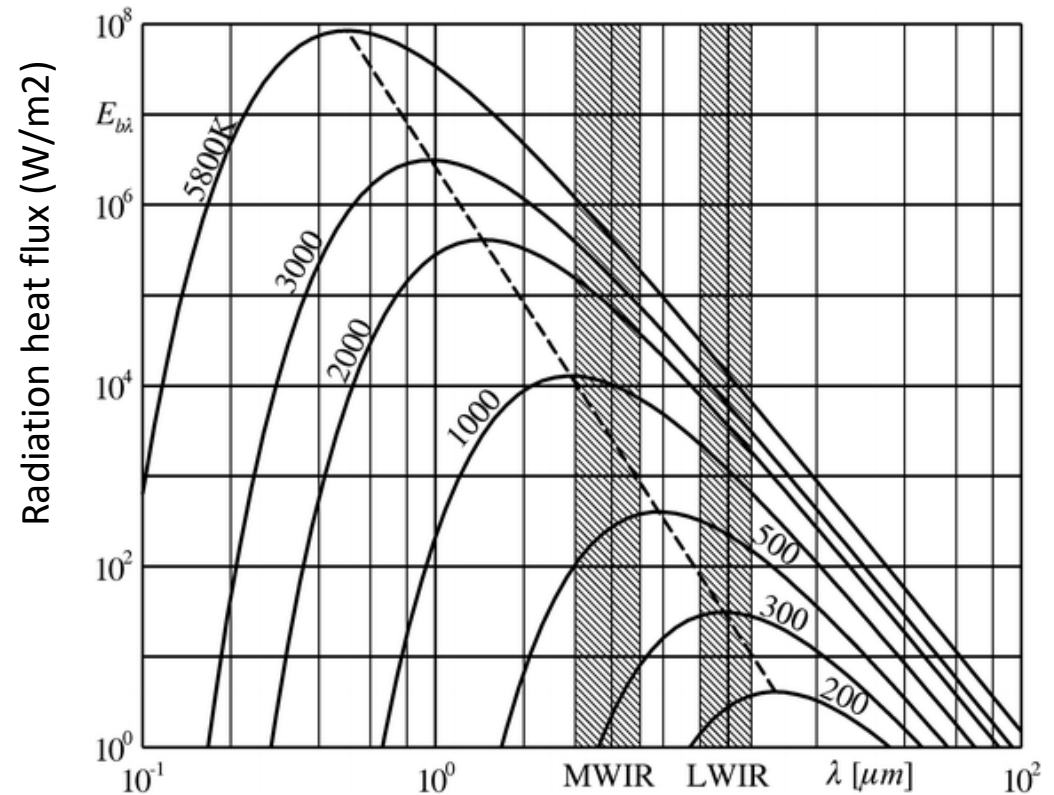
Influence of partial reflection:

- Disturbing background radiation from a 3000 K hot lamp
- Radiated power in MWIR is 13 times higher than in LWIR
- Primary signal (difference between 300K and 295K) is significantly smaller in MWIR.

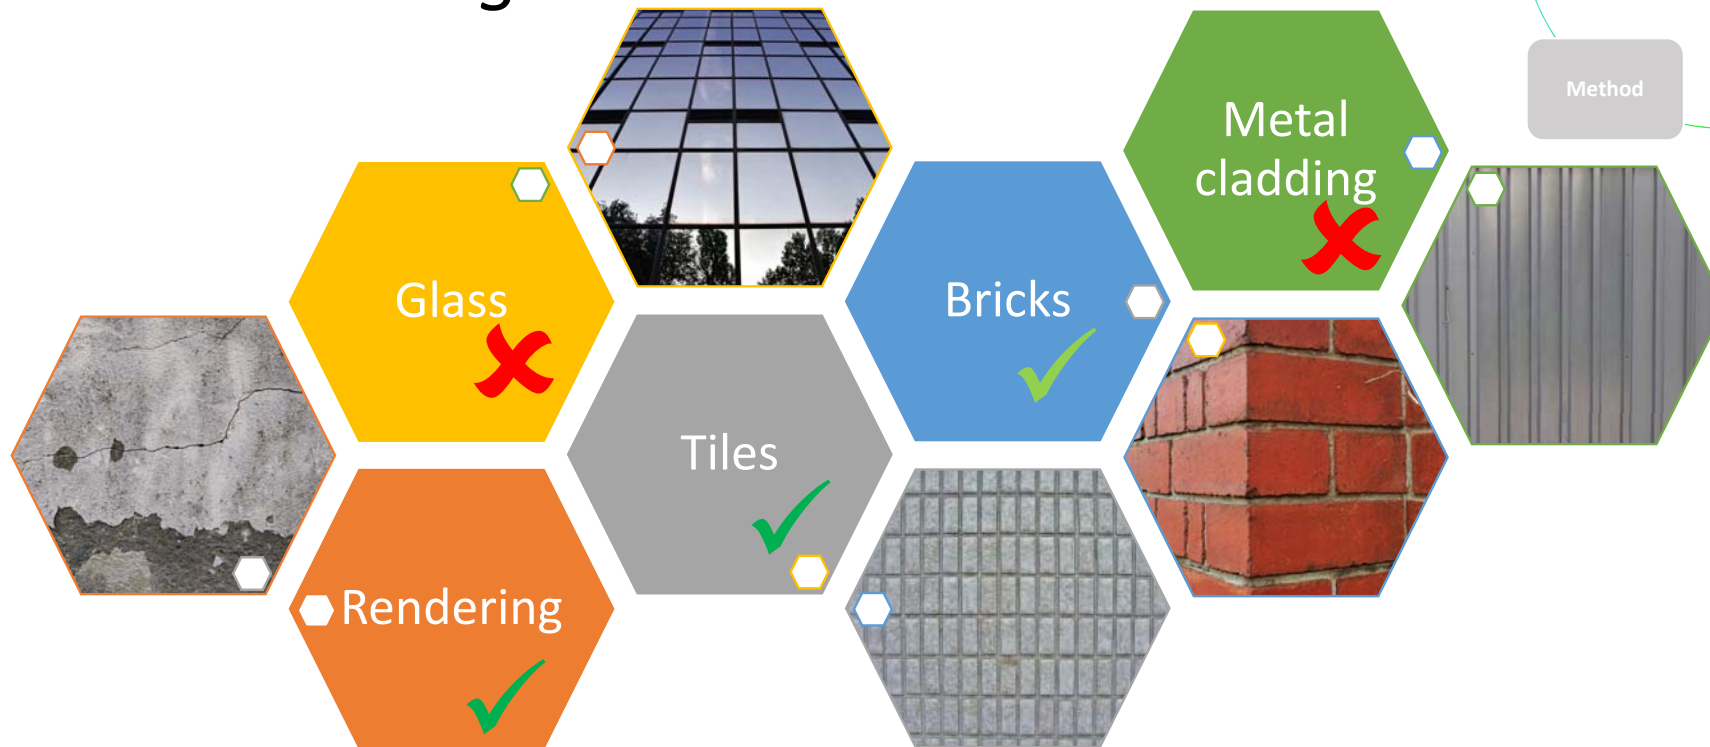
Depends on the emissivity of the material

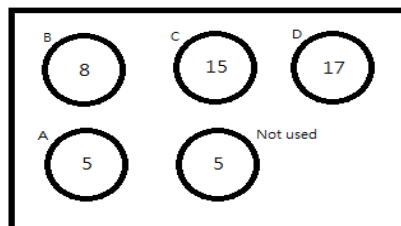
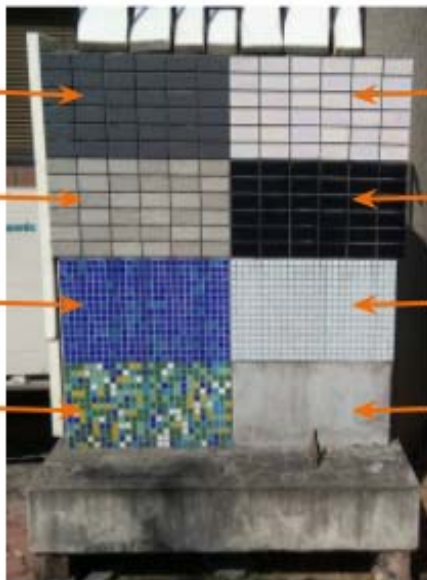
8 demonstrates the depth of debond (in mm)

- Tile: Matt Black  
Size: 95mm x 45mm
- Tile: Grey Ceramic  
Size: 95mm x 45mm
- Tile: Blue Mosaic  
Size: 19mm x 19mm
- Tile: Mixed-color Mosaic  
Size: 19mm x 19mm

- Tile: Reflective White  
Size: 95mm x 45 mm
- Tile: Smooth Black  
Size: 95mm x 45 mm
- Tile: White Mosaic  
Size: 19mm x 19 mm
- Tile: Fair-face Concrete  
Size: N/A

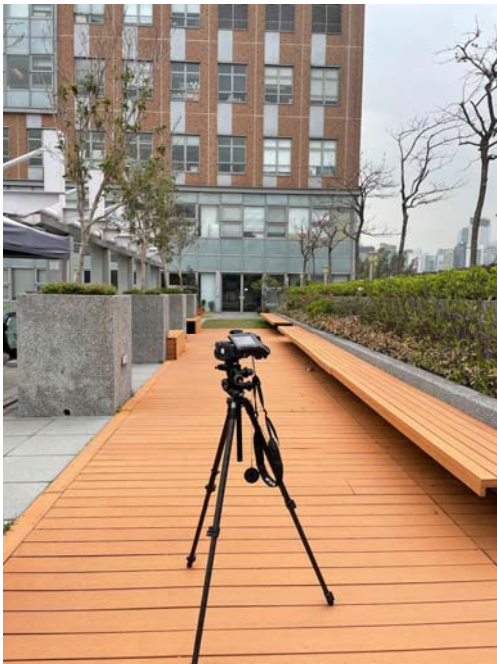
Normal case – ground-based

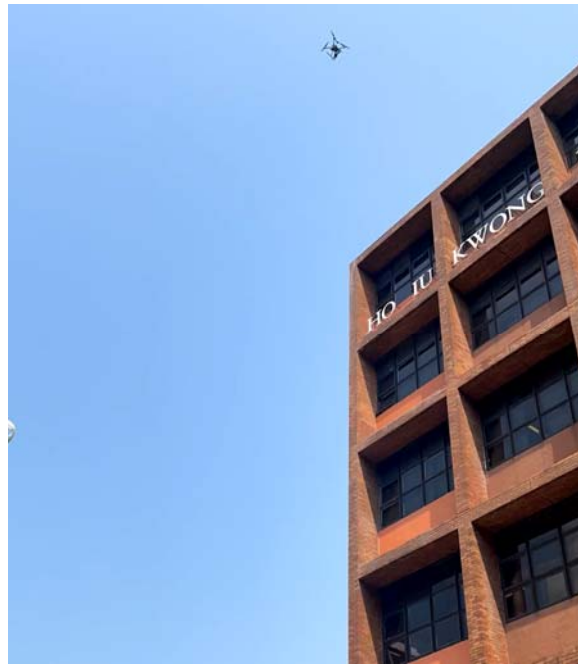
High-rise buildings – with UAV

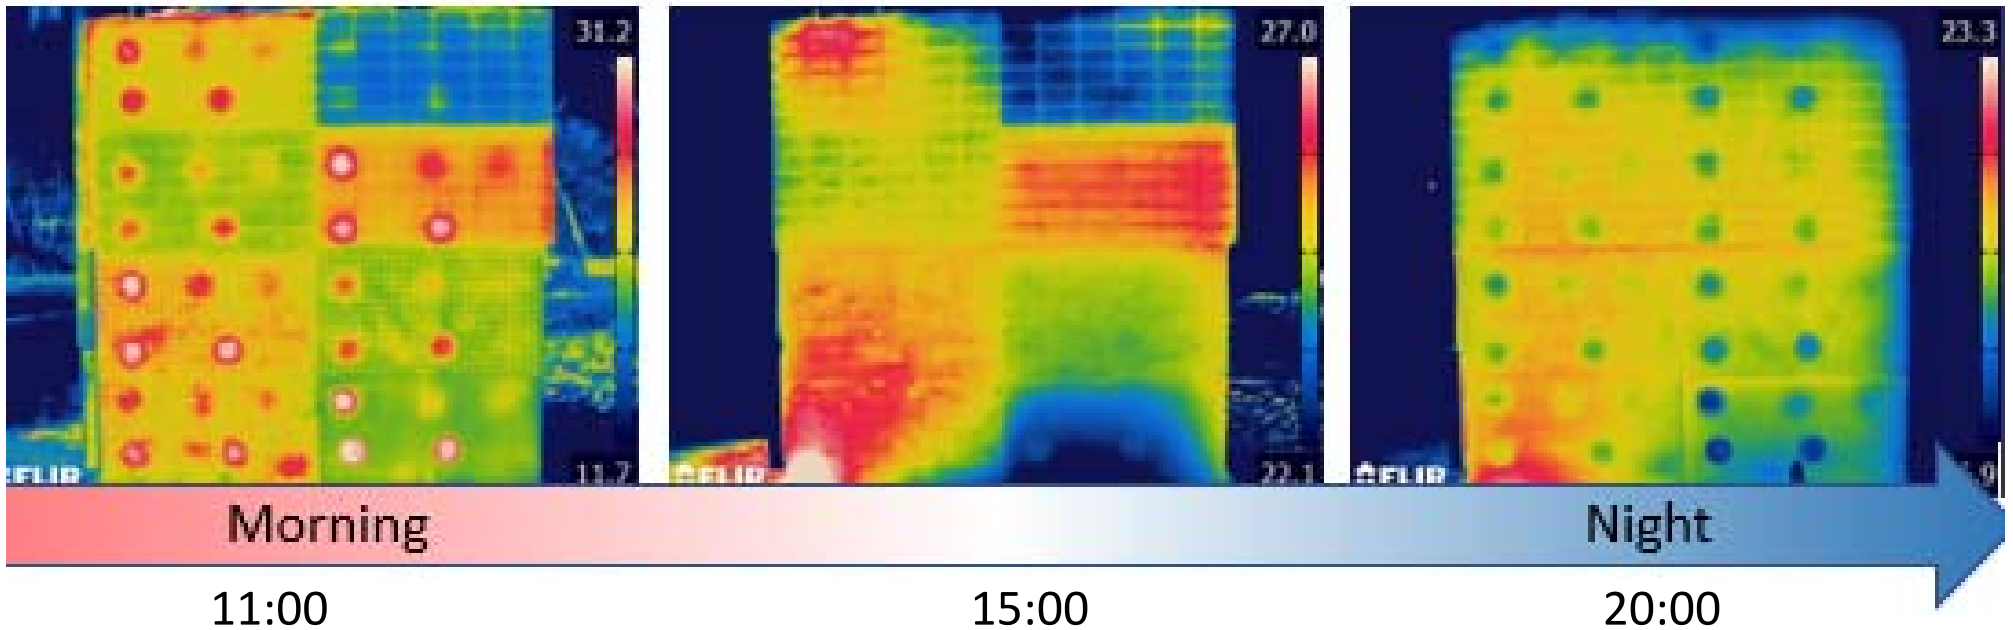
Time Factor

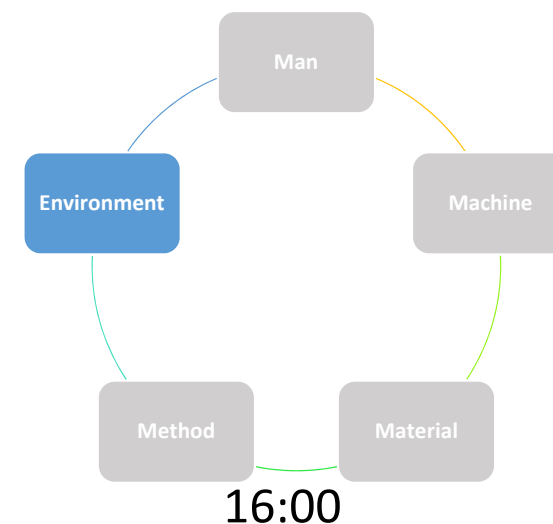
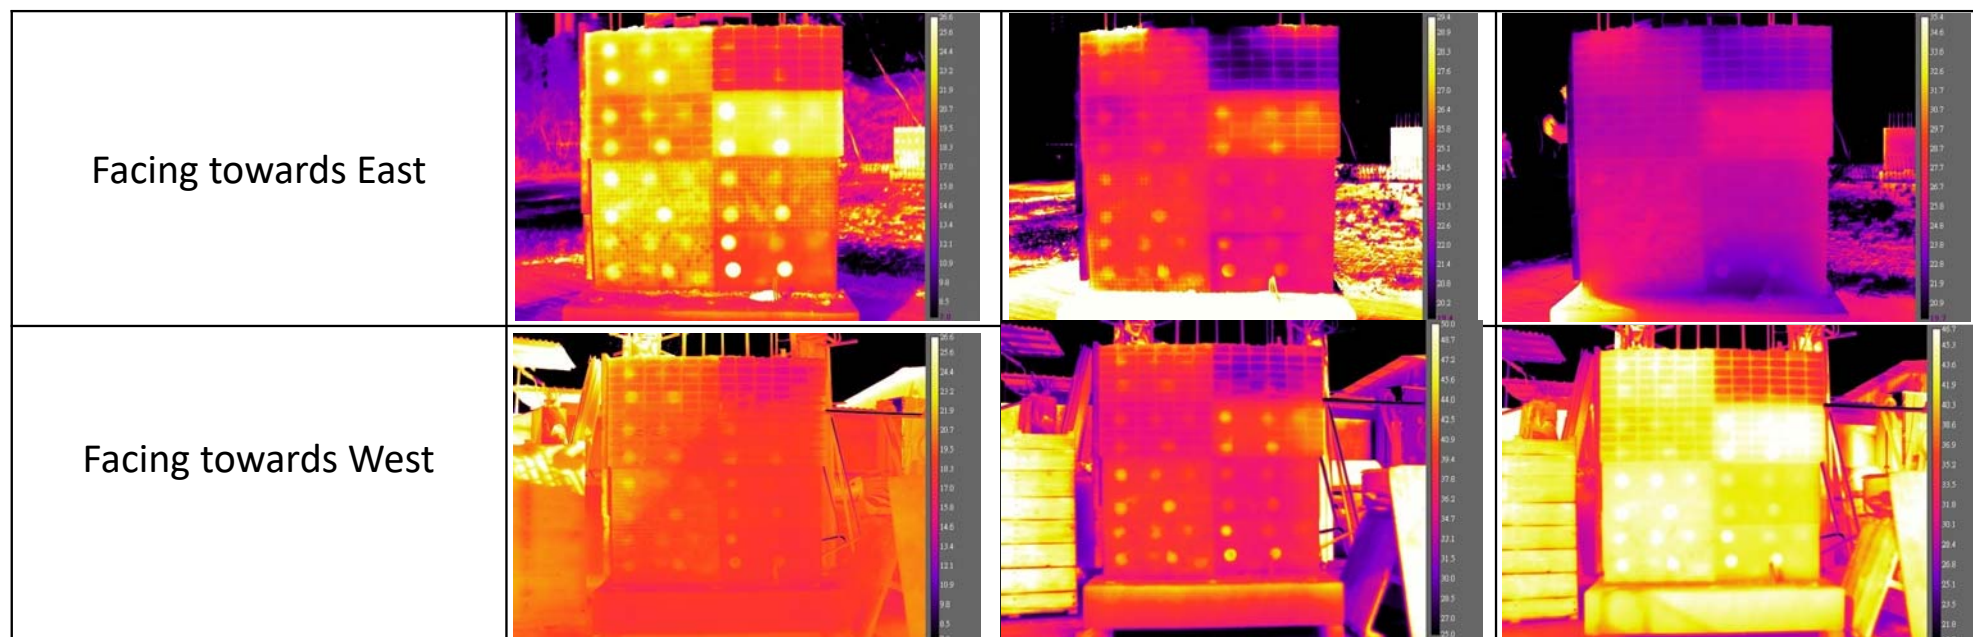
Orientational Factor

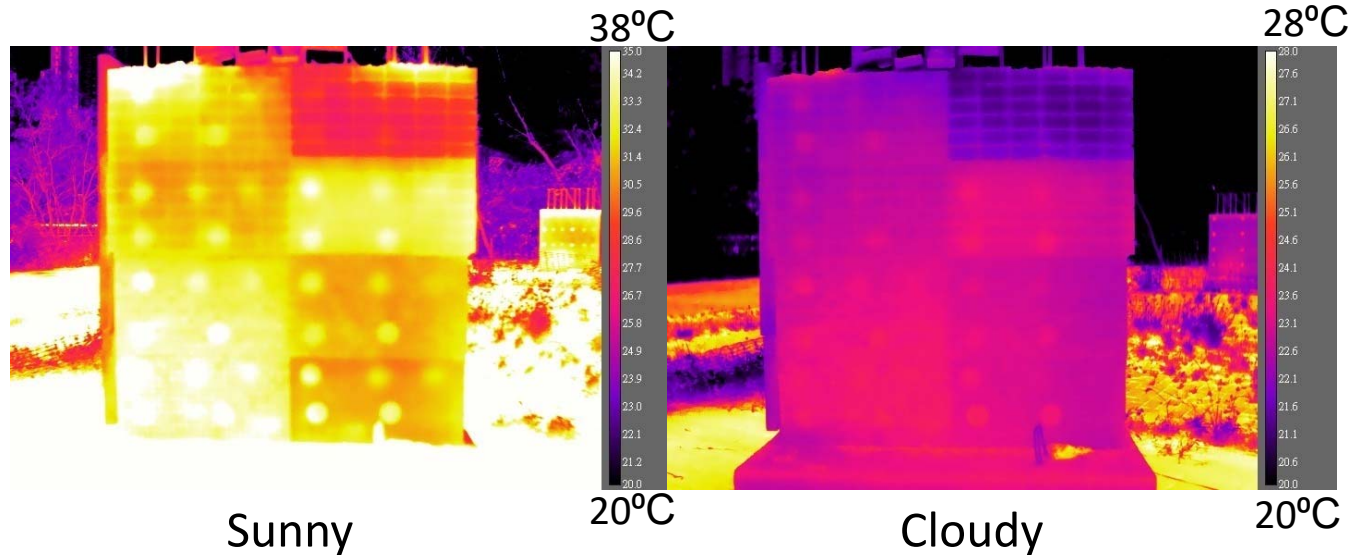
- Cloud coverage:  $< 6/8$
  - Wind speed:  $< 6.5 \text{ m/s}$
  - 2-3 days prior to survey
- **at least 12 hours** prior to survey

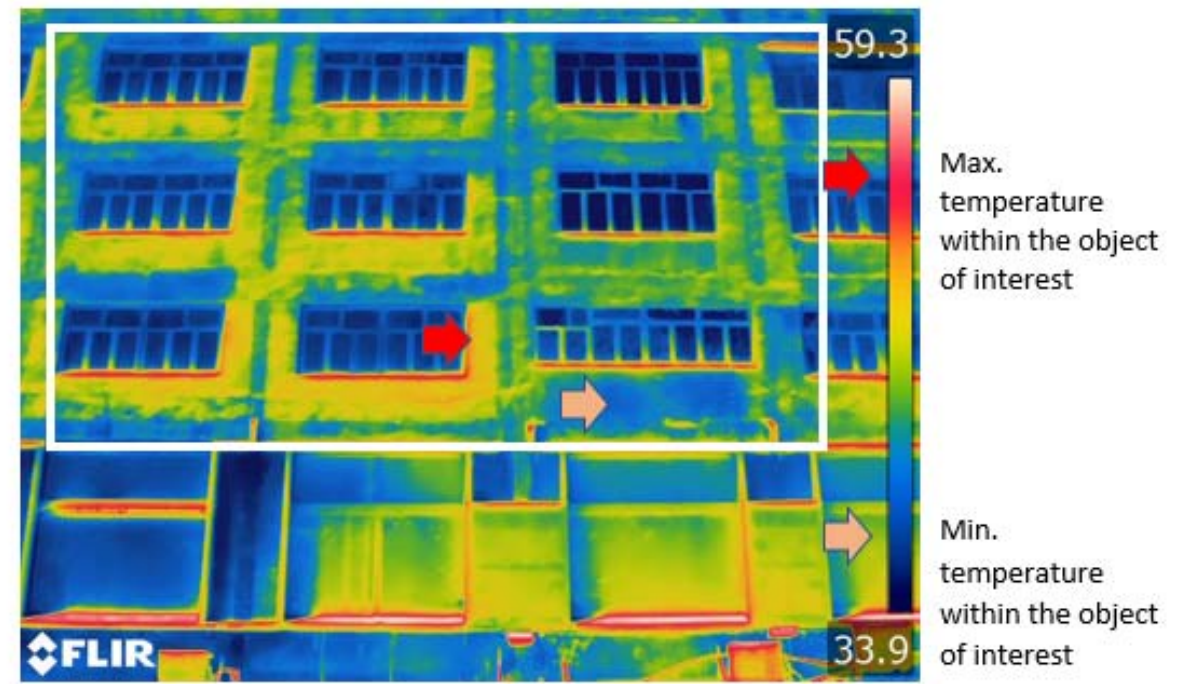
- Temperature span: max. and min. temperature within objects of interest
- Evenly/linearly distributed colour palette
